# **Pentium<sup>®</sup> III Xeon<sup>™</sup> Processor Specification Update**

Release Date: February 2000

Order Number: 244460-011

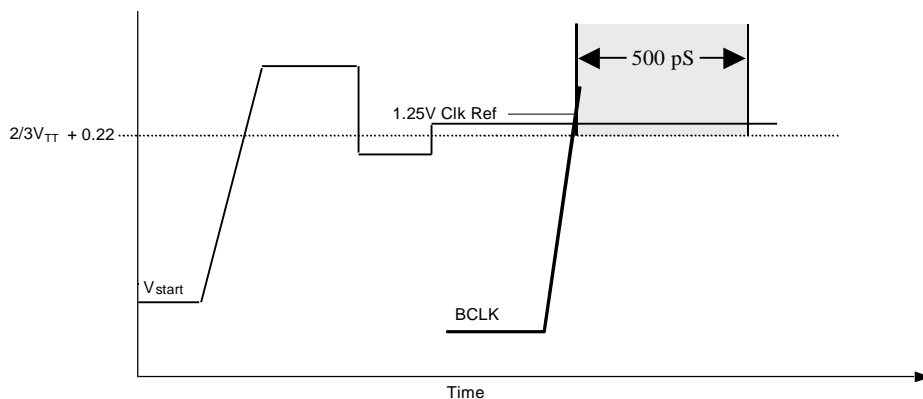
The published AGTL+ AC specification for  $V_{IH(MIN)}$  is  $(2/3 \cdot V_{TT}) + 0.1$  Volts.

Intel has characterized the new AGTL+ AC specification for  $V_{IH(MIN)}$  on the processor's RS0# signal to be:  $(2/3 \cdot V_{TT}) + 0.22$  Volts within 500 picoseconds following the rising edge of BCLK crossing the 1.25-Volt threshold. See below.

**Implication:** The deviation from the published specification results in decreased noise margin on the RS0# processor input. This decreased noise margin has been observed to be particularly detrimental in system environments where the RS0# processor input is being driven by an I/O buffer with a pull-up device (such as a p-channel transistor) that is switched off mid-cycle. Systems which employ I/O buffers that keep the pull-up device on for the entire cycle are significantly less affected by this erratum. The reduction in noise margin may lead to the generation of BINIT# (when enabled) resulting in a system reset, otherwise this condition may lead to a system "hang" condition.

**Workaround:** If a system design cannot meet the specification deviation, the following areas should be carefully examined to assure that additional margin exists in order to compensate for any deficit observed with respect to the newly characterized  $V_{IH(MIN)}$  specification:
